## TEST REPORT

No. : XMIN2208008097CM

Sample Name : Three-layer solid wood composite floor  
Product Specification : 1210\*165\*15/3.0  
Material and Mark : oak

Test Item: Impact Resistance

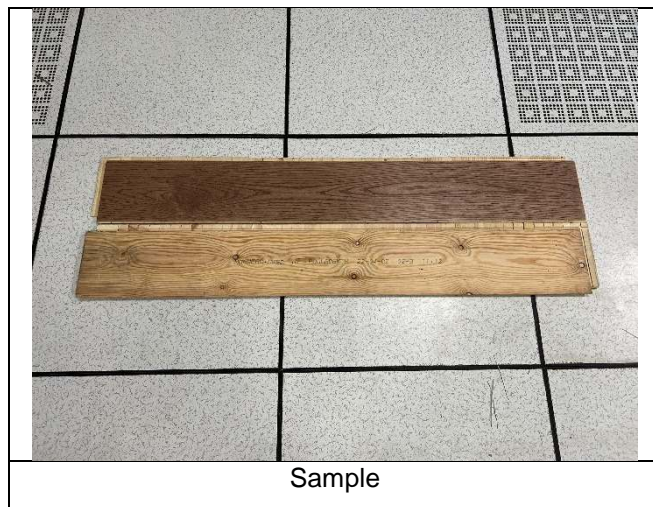
Original Sample Photo:

Sample Description: See photo

Specimen: 300mm×165mm×15mm
