# No. 1487230.3

SAMPLE DESCRIPTION:  
Flooring Planks – 12mm AquaREPEL water resistant laminate flooring assembly with D3 rate PVA adhesive applied in the joints and IXPE 2mm underlay attached to the bottom as a complete floating installation system.  
Code: PK7088W Classic Beige Oak

## ISO 4760:2022(E) - LAMINATE FLOORING – TOPICAL MOISTURE RESISTANCE – ASSEMBLED JOINT (MODIFIED)

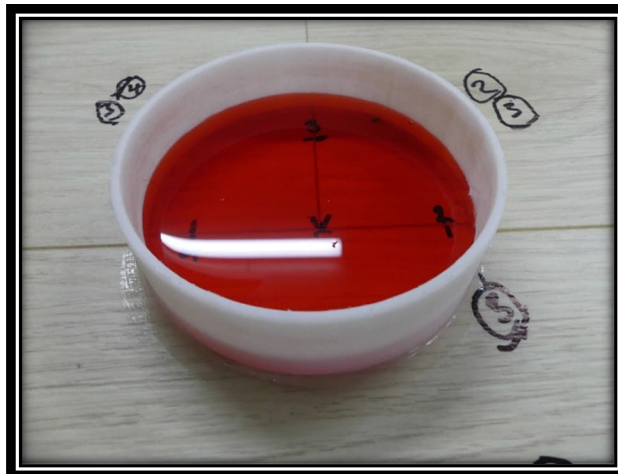
After 24 hrs With Water

Observations:	Specimen 1	Specimen 2	Specimen 3
Migration of water along the upper surface:	No	No	No
Migration of water to the underside:	No	No	No

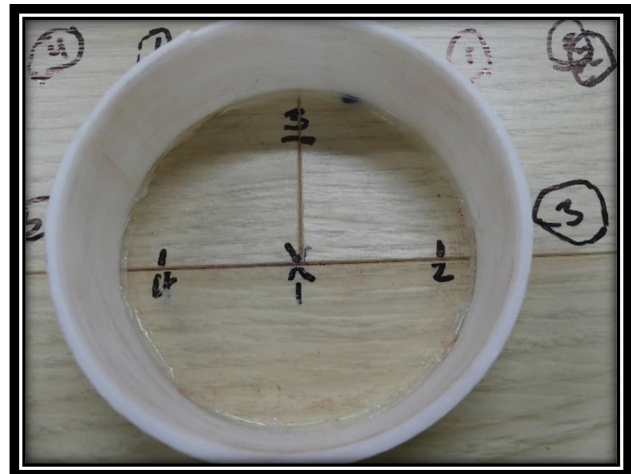
Wet Swell

Quantitative Results:	Wet Swell (mm)			Recovered Swell (mm)		
	Specimen 1	Specimen 2	Specimen 3	Specimen 1	Specimen 2	Specimen 3
Final Average (Positions 2 to 4)	0.20	0.33	0.40	0.11	0.37	0.51
Final average (Position 1)	0.39	0.42	0.62	0.33	0.60	0.71

Wet Swell			Recovered Swell		
	Specimen 1	Specimen 2	Specimen 3	Specimen 1	Specimen 2	Specimen 3
Qualitative Ratings (individual results):	2	2	2	2	2	2
