No. 1484669.5

SAMPLE DESCRIPTION:
Flooring planks – 15mm Engineered hardwood flooring assembly with Selleys Aquadhere Exterior D3 rate adhesive applied in the joints and IXPE standard underlay attached to the bottom as a complete floating installation system: Oak Nature-OT10255-15mm.

ISO 4760:2022(E) - LAMINATE FLOORING – TOPICAL MOISTURE RESISTANCE – ASSEMBLED JOINT (MODIFIED)

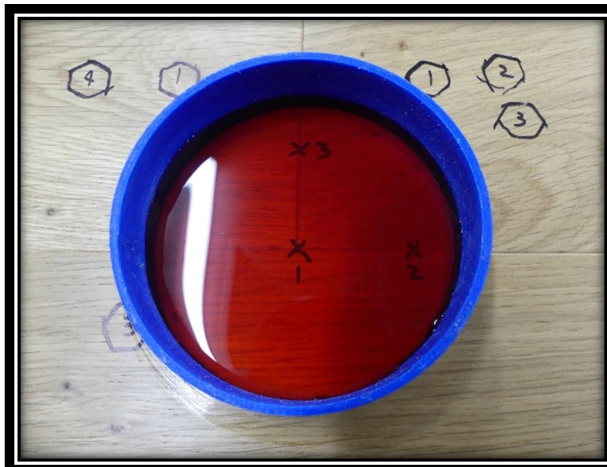
After 24 hrs With Water

100 mls of dye solution was applied onto the sample surface. It was poured into a cylinder 100mm diameter placed in the centre of the sample at the "T joint." Sealant was used at the plank/cylinder interface to avoid leakage.

The sample was left at 20°C, 65% Relative Humidity room conditions for 24 hours after the dye was added and then examined for dye penetration through the backing (not 23°C, 50% RH as stated in the method).

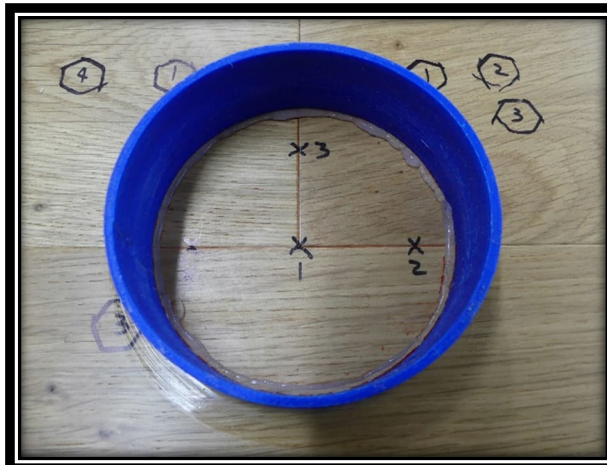
Recovered Swell
