TEST REPORT

Laminate floor

210423002SHF-003

EN 13501-1:2018 Fire classification of construction products and building elements - Part 1: Classification using data from reaction to fire tests

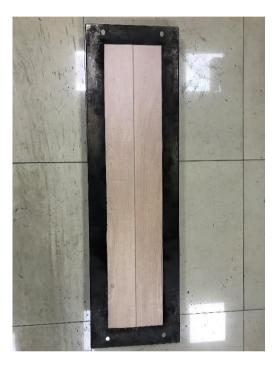
4 Test Photos of EN ISO 9239-1

Before test After test

The test was conducted in accordance with EN ISO 9239-1:2010. This test evaluates the wind-opposed burning behaviour and spread of flame of horizontally mounted floorings exposed to a heat flux radiant gradient in a test chamber, when ignited with pilot flames.
