**No. 1551309.6**

SAMPLE DESCRIPTION:  
12mm AquaREPEL laminate flooring planks assembly  
with Woodlok 2500 D3 Crosslinked adhesive applied in  
the joints.  
PK7094WP – Cocoa Oak

**ISO 4760:2022(E) - LAMINATE FLOORING – TOPICAL MOISTURE RESISTANCE – ASSEMBLED JOINT (MODIFIED)**

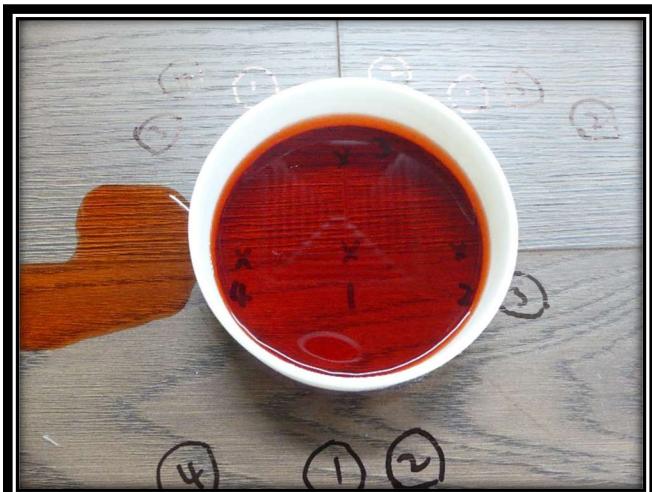
After 24 hrs With Water

100 mls of dye solution was applied onto the sample surface. It was poured into a cylinder 100mm diameter placed in the centre of the sample at the "T joint." Sealant was used at the plank/cylinder interface to avoid leakage.

The sample was left at 20°C, 65% Relative Humidity room conditions for 24 hours after the dye was added and then examined for dye penetration through the backing (not 23°C, 50% RH as stated in the method).

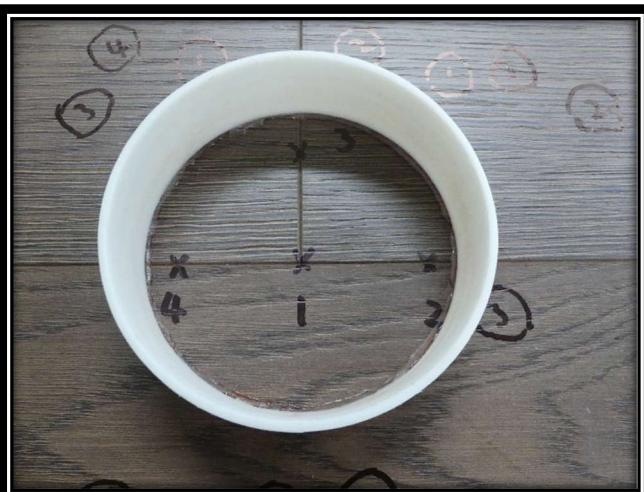
Wet Swell

Quantitative Results:	Wet Swell (mm)			Recovered Swell (mm)		
	Specimen 1	Specimen 2	Specimen 3	Specimen 1	Specimen 2	Specimen 3
Final Average Results (Positions 2 to 4)	0.16	0.15	0.15	0.12	0.08	0.16
Final Results (Position 1)	0.13	0.10	0.22	0.11	0.09	0.22

Observations:	Specimen 1	Specimen 2	Specimen 3
Migration of water along the upper surface:	Yes	Yes	No
Migration of water to the underside:	No	No	No

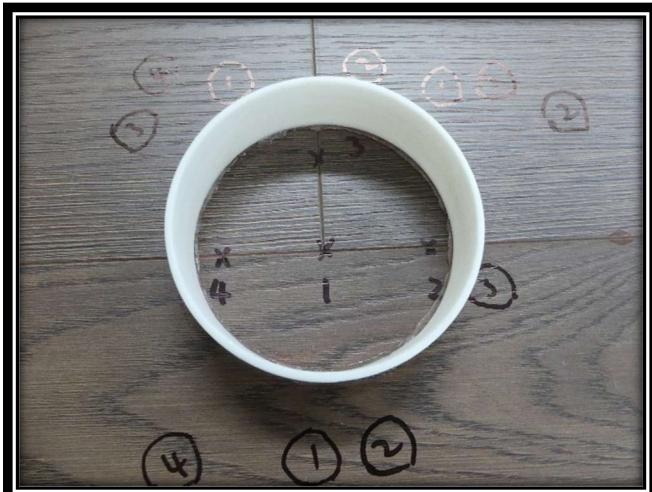
Recovered Swell

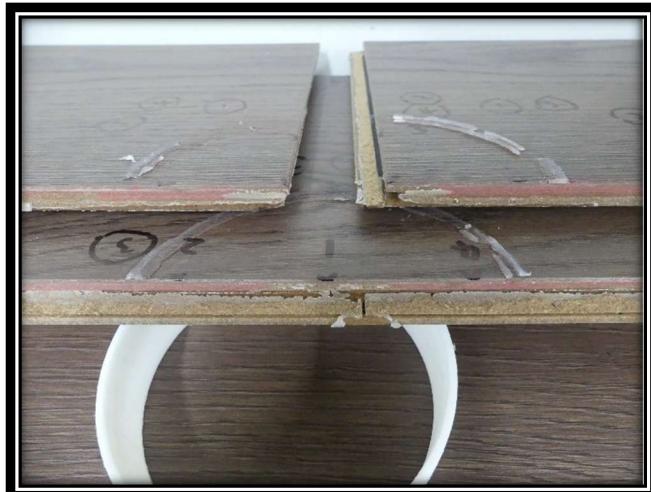
Recovered Swell (Disassembled)

Disassembly Observations:	Specimen 1	Specimen 2	Specimen 3
Migration of water along the upper surface:	Yes	Yes	Yes
Migration of water to the underside:	No	No	No
