## TEST REPORT

No. : XMIN2208008097CM

Sample Name : Three-layer solid wood composite floor  
Product Specification : 1210\*165\*15/3.0  
Material and Mark : oak

Test Item: Impact Resistance

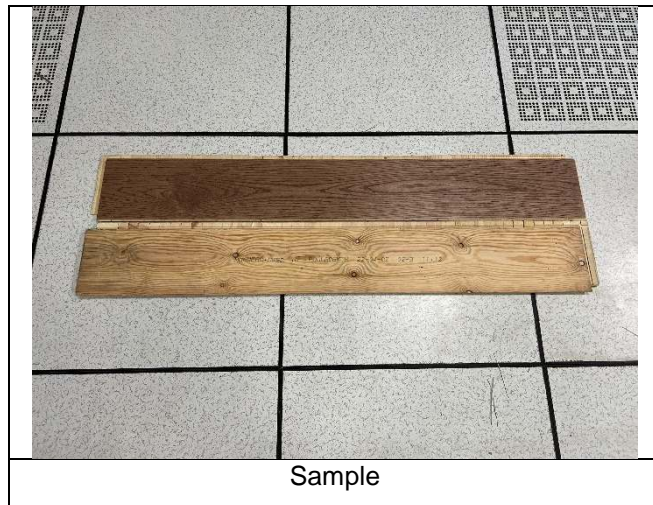
Original Sample Photo:

Sample Description: See photo
